# SERVICE BULLETIN

**NO. ARC 852-005** Rev. A

**Aircraft Restoration Corporation**

Bumper Brackett, P/N 85280119-00 interference with the rib doubler support angle at wing station 49.0.

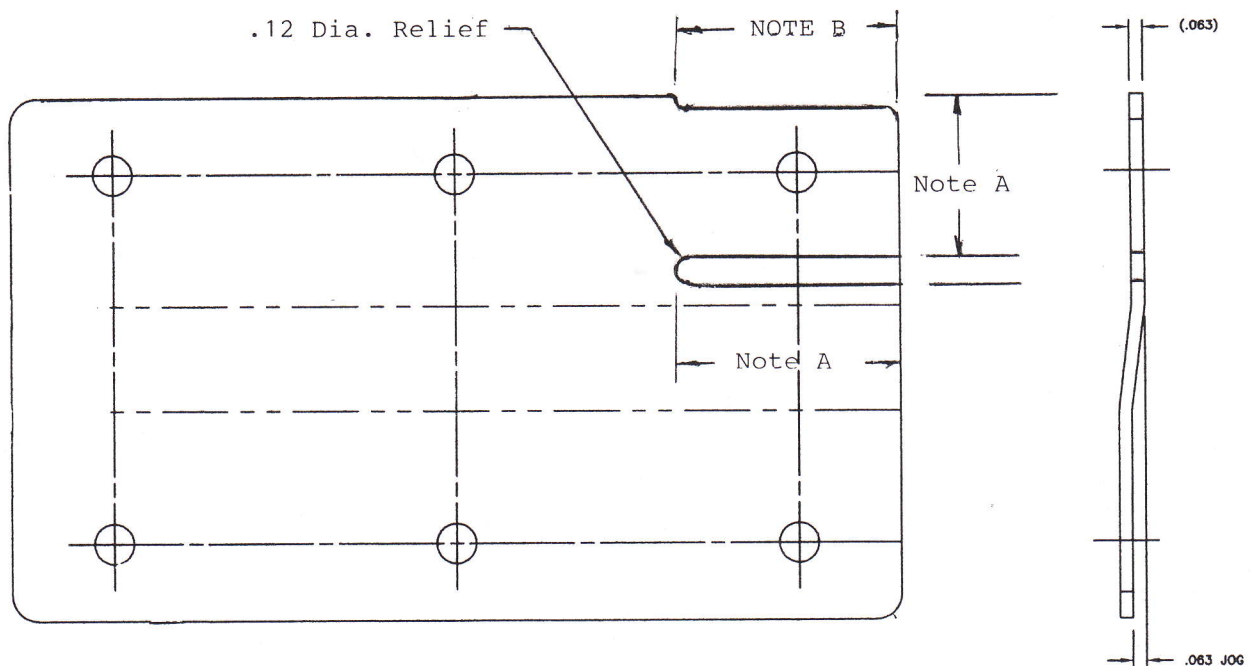
Installation Procedures and the attached drawing. Position the bracket in its installed position, if the rib angle interferes cut a .12 notch in the bracket to eliminate the interference (NOTE A). Additionally, the top of the bracket might contact the same rib angle where it attaches to the wing skin (NOTE B). Remove as little material as possible to ensure a minimum of .02 clearance on all sides of the bracket.

**NOTE A:**

Final dimensions are determined at the time of installation, sufficient to maintain a minimum of .02 clearance.

**NOTE B:**

Remove material necessary to provide .20 clearance to the top of the rib angle and wing skin.
